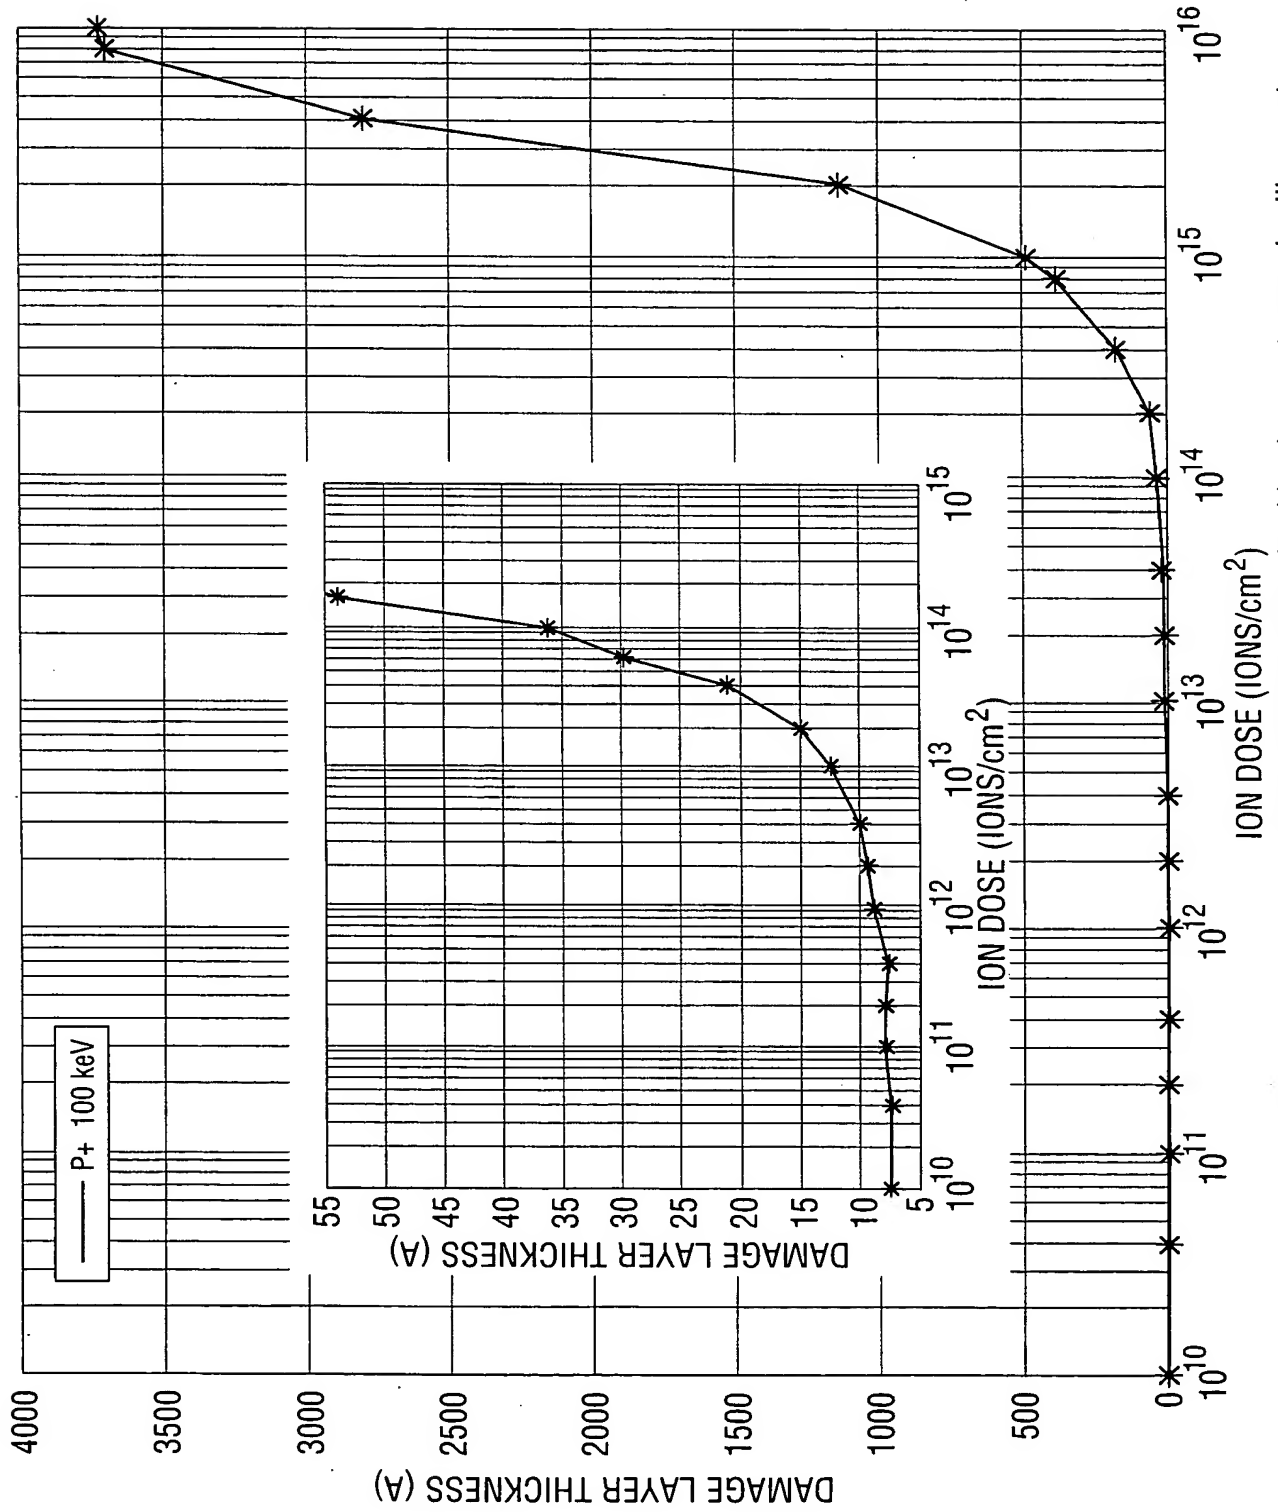
FIG. 2

The damage layer thickness across the full dose range as determined by the spectroscopic ellipsometer.

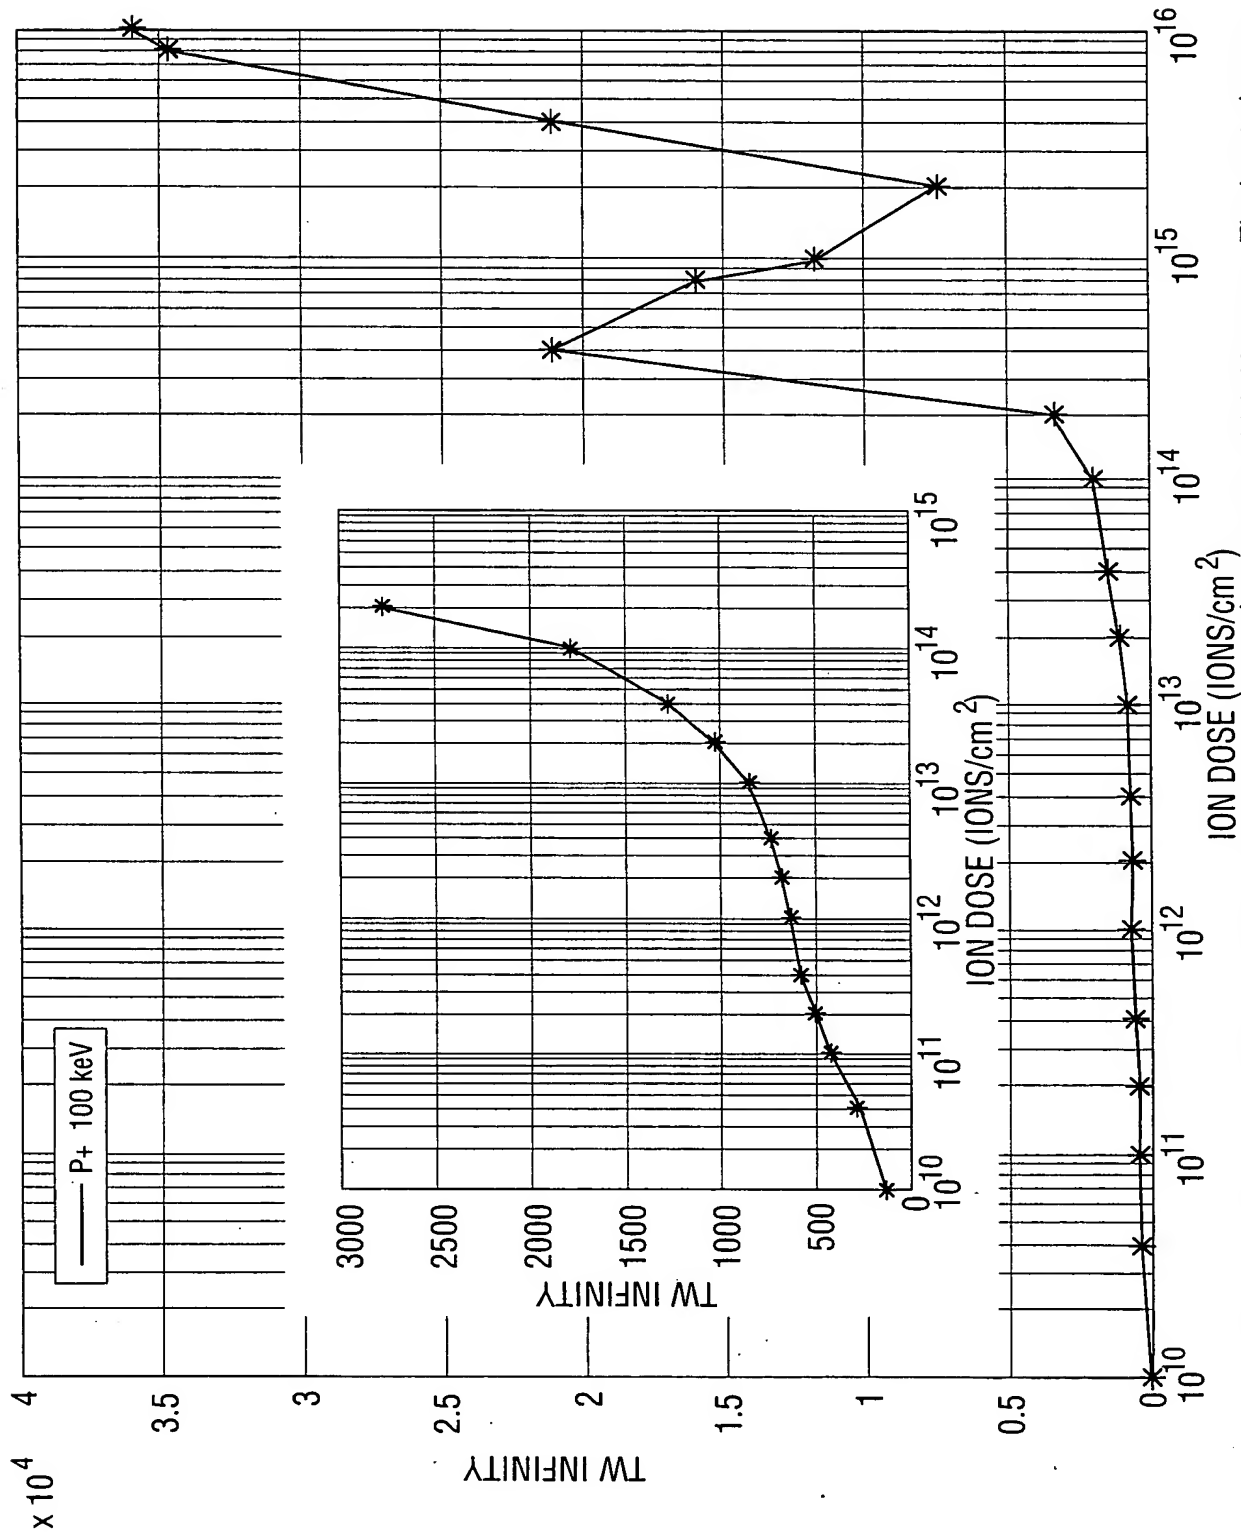
**FIG. 3**

The thermal wave response across the full dose range for P<sup>+</sup> implant at 100 keV energy. The inset shows a close-up to the low sensitivity region.
